## Docket No. 272 - Development and Management Plan Inspection

## **Segment 4b Underground Line**

Date: November 1, 2006 (Evening inspection)

Location: Fairfield/Westport Town Line to Westport Avenue in Norwalk

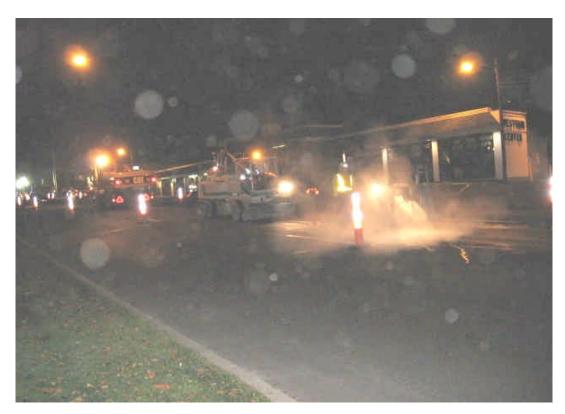
Photo of trenching and saw cutting activities in Westport from Buckley Ave. to Westfair Dr. Please note that sweeper truck is immediately following saw cutting activity to remove sediment from the roadway.
